Westernport and Peninsula Protection Council and Save Westernport Inc.

Western Port Marine Pest Survey

This letter report describes the results of marine pest inspections at Yaringa Boat Harbour and Stony Point Jetty in September 2021.

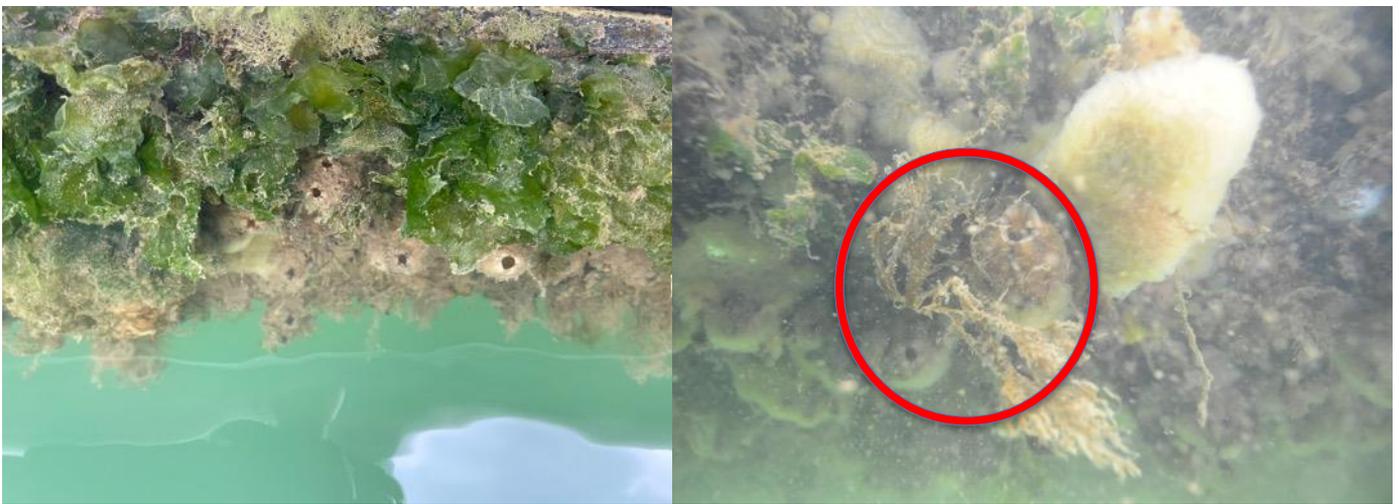
Figure 4. Introduced marine species identified at Yaringa Boat Harbour.

(a) *Ulva lactuca* and *Styela plicata* on floating pontoon, *S. plicata* circled at right

Ulva (sea lettuce) was observed in high abundance attached to floating pontoons. High abundance may indicate high nutrient loads entering the water way. While the sea lettuce is not noxious, it can become invested with epiphytes and sediment, die off and cause clogging of water ways and cause poor visual amenity.

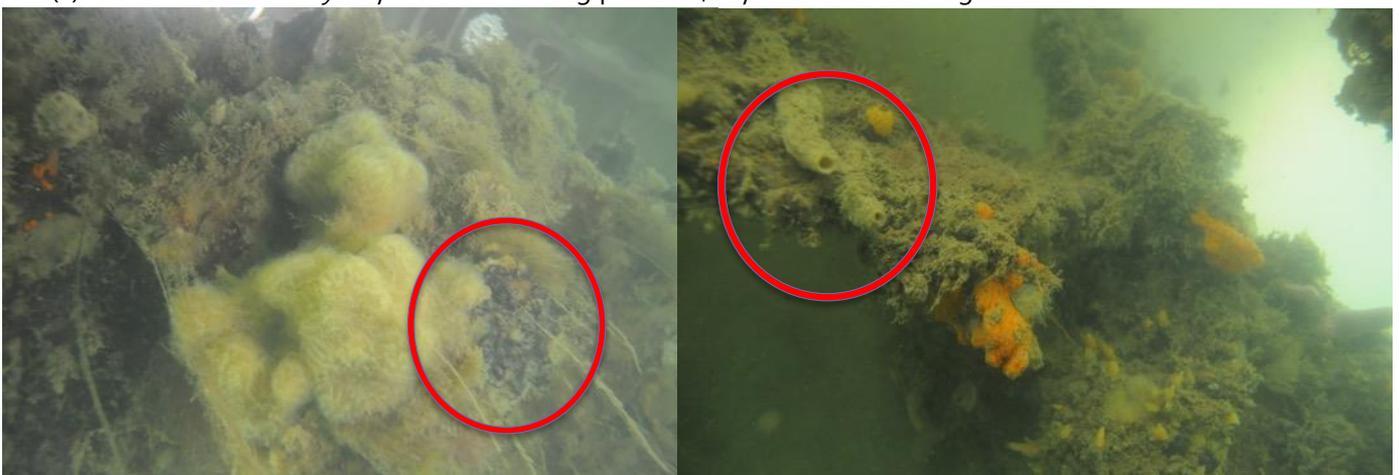
(b) *Botryllus schlosseri* among biological matrix

(c) *Ciona intestinalis* among biological matrix

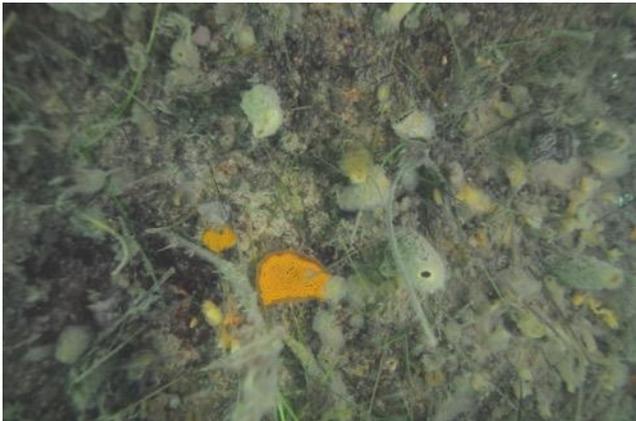
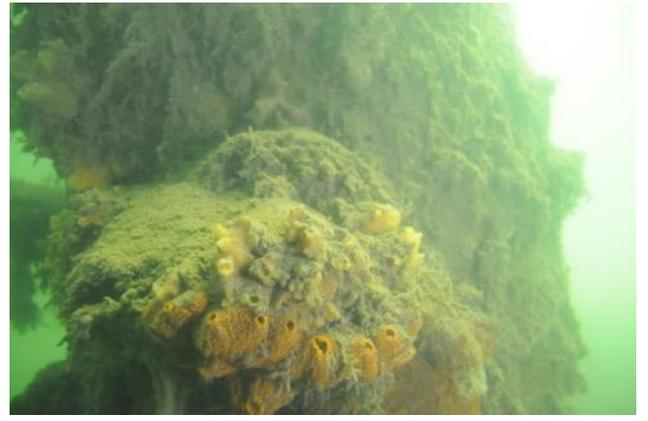
(e) Biological matrix typifying growth on the underside of floating pontoons (left) and the hulls of older vessels (right)
